### *HOME INSPECTION REPORT*

File Number: **NC0414961**

Address of Inspection: **3006 N Patterson Ave**

**Jose Melendez**  
**3006 N Patterson Ave**  
**Winston-Salem, NC 27105**

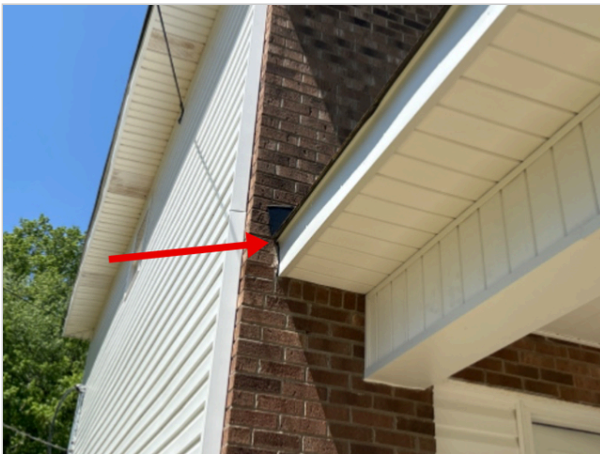
Front left

***Unsealed areas observed at the front of the siding/trim on the house. This is a water penetration/damage concern. Recommend repairs by a qualified person.***

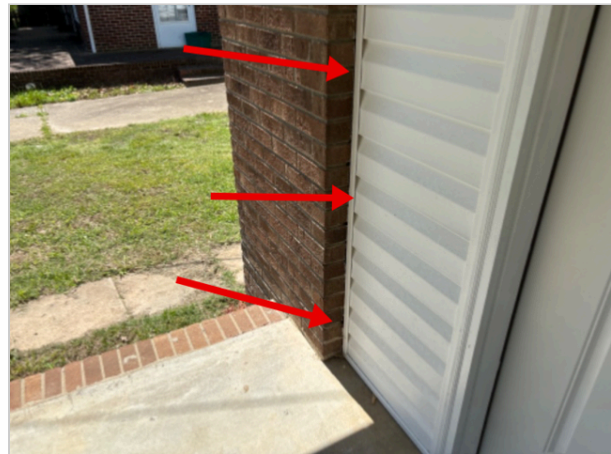
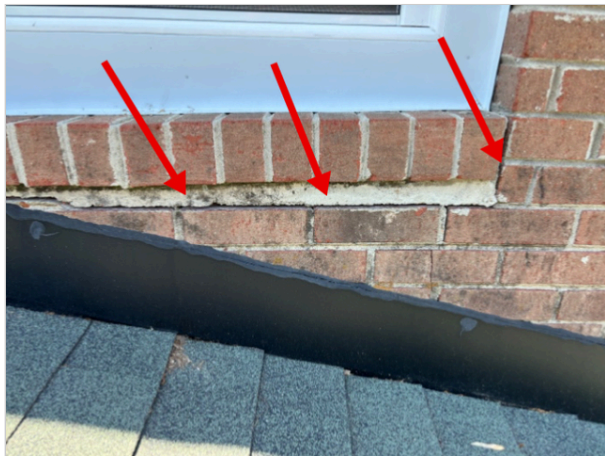
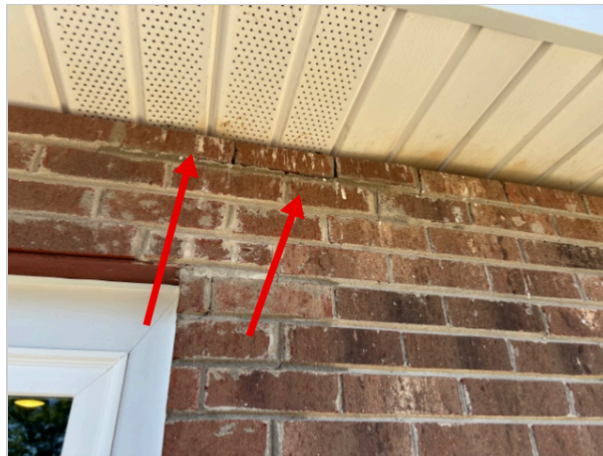
***Wall cracking/open gaps observed at Above front porch. This is a settlement/water penetration concern. Recommend repairs by a qualified contractor.***

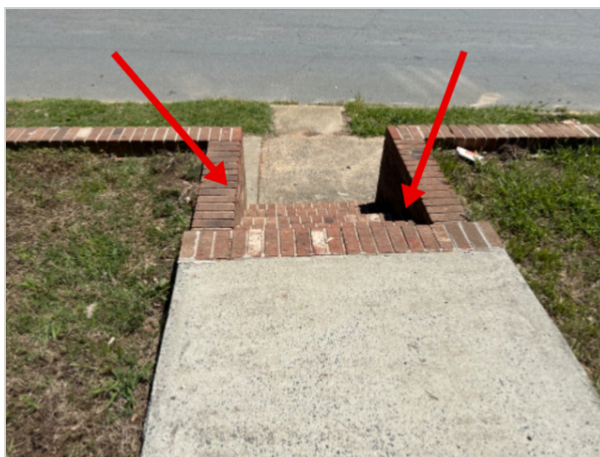
***No railings were installed at the front porch. This is a safety/fall concern as areas were over 30 inches tall. Recommend repairs as necessary by qualified contractor.***

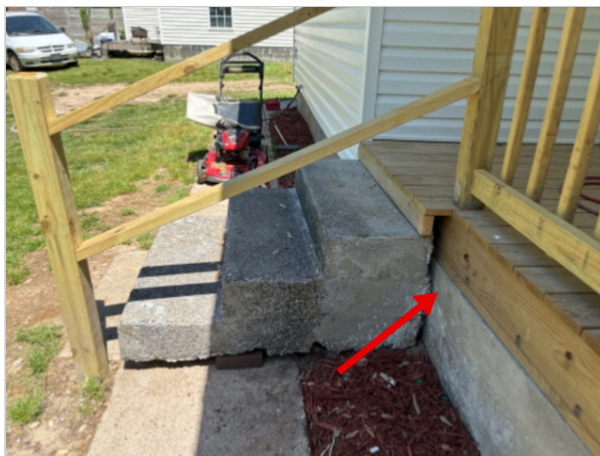
***Settlement observed at the porch stairs at the rear of the house. This leaves step not attached to the home . This is a settlement/trip concern. Recommend repairs by qualified contractor.***

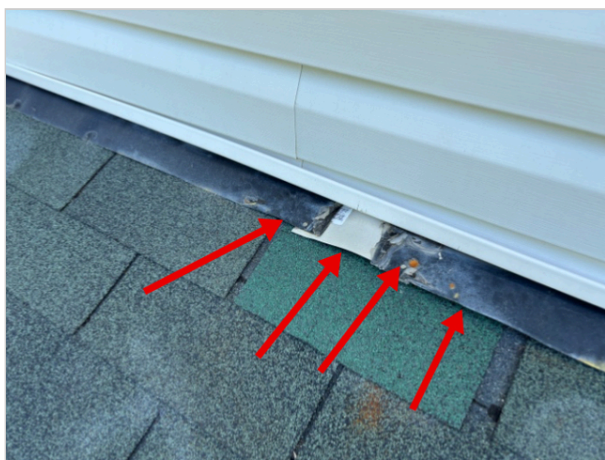
Rear

***Unsealed nails/ flashing were observed at multiple areas of the roof. This is a water penetration/substrate damage concern. Recommend repairs by qualified person.***

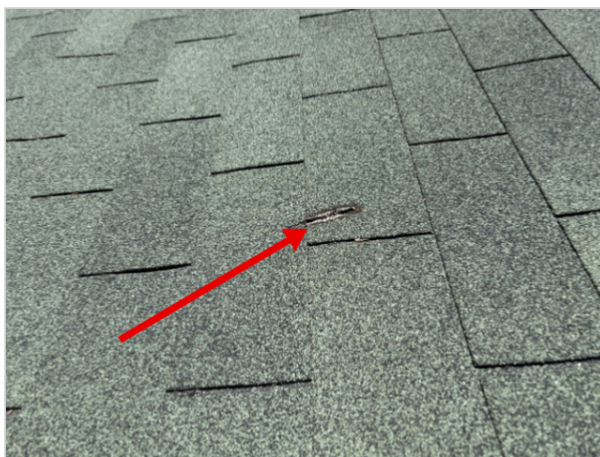
***Damaged shingles were observed at the front of the roof. This is a damage/water penetration concern. Recommend repairs by a qualified contractor.***

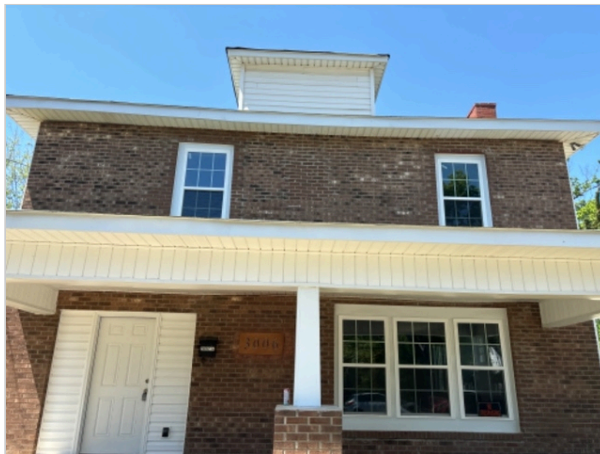
***Note to Client: The home does not have gutters installed. Although not required, client may wish to upgrade to ensure proper drainage away from the foundation/structure.***

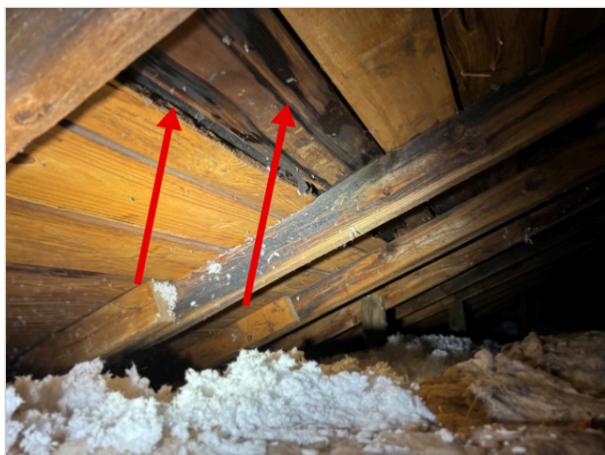
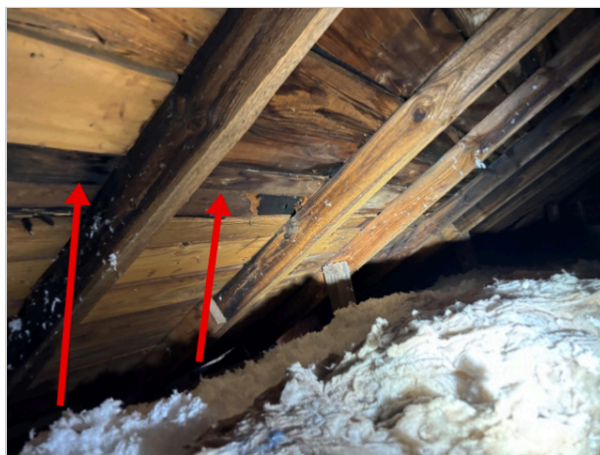
***Staining was observed on the framing at multiple areas of the attic. Moisture levels were not tested as area(s) was inaccessible. This is a leakage/damage concern. Recommend verifying conditions and/or having further review and repairs as necessary by a qualified contractor.***

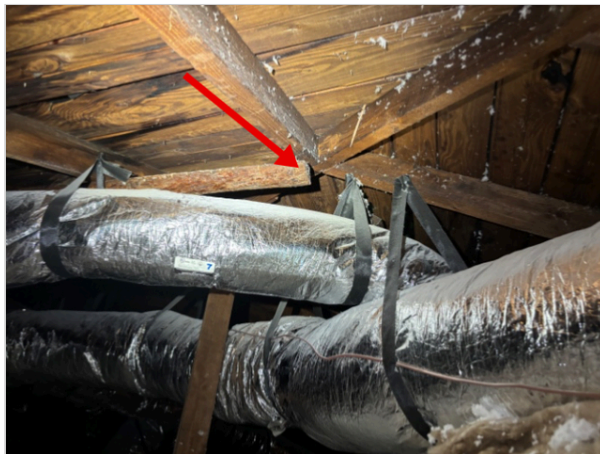
***The attic framing were loose/unsecured in areas. This is a support concern. Recommend repairs by qualified person.***

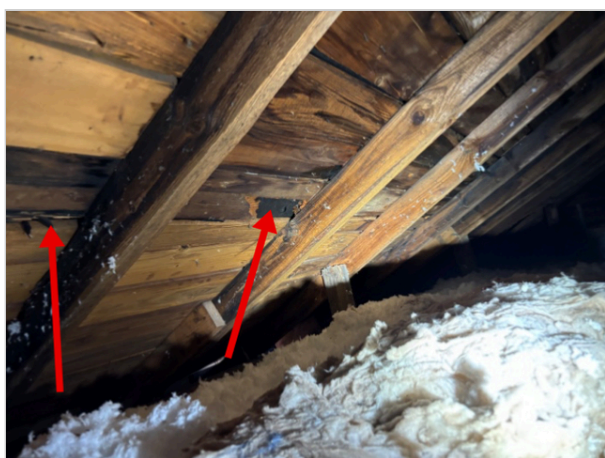
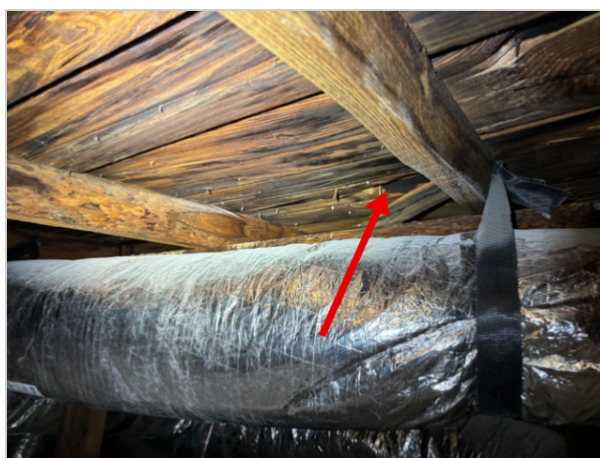
***Damage was observed on the attic decking at Left side. This is a support/damage concern. Recommend repairs by qualified contractor.***

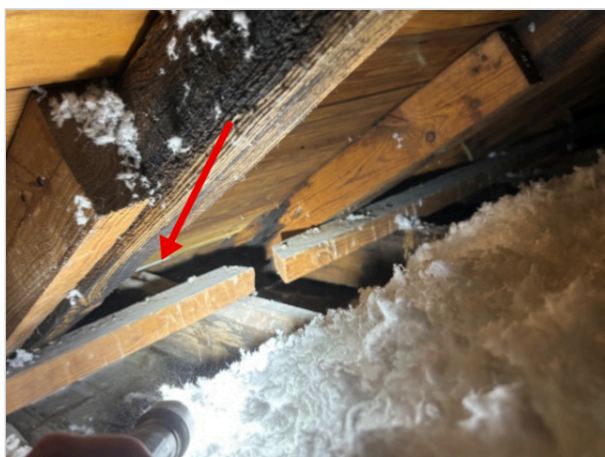
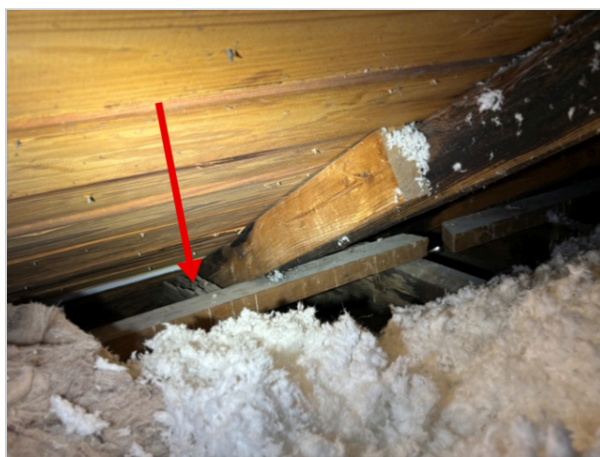
***Cracking was present on the framing at the left of the attic. This is a support/damage concern. Recommend repairs as necessary by qualified contractor.***

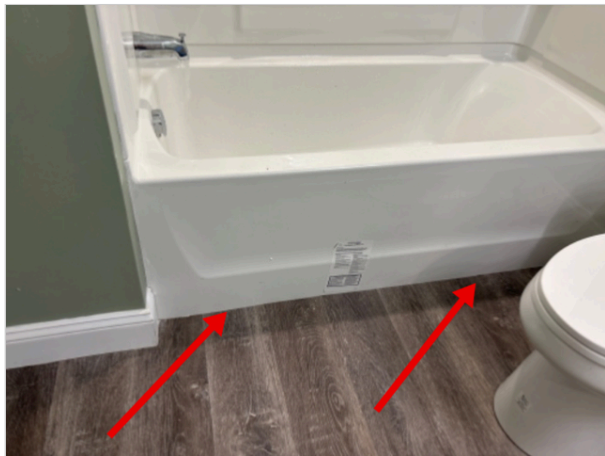
First floor

***Unsealed areas were observed at the surrounds at the bathrooms. This is a leakage and substrate damage concern. Recommend repairs by qualified person.***

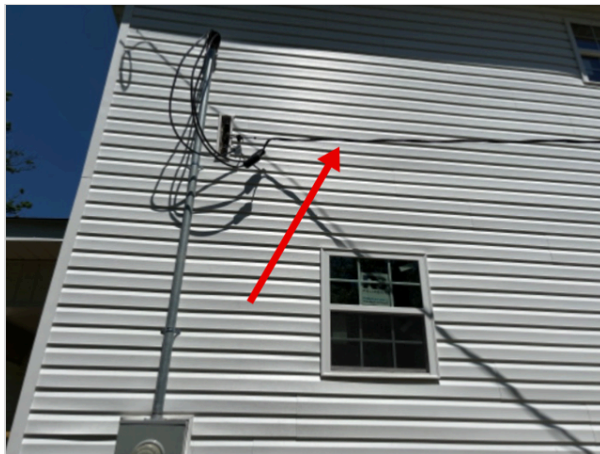
***Improper electric service line height clearance was observed over the window at the left of house. This is a safety/clearance concern. Recommend discussing conditions with utility provider and have repaired as directed.***

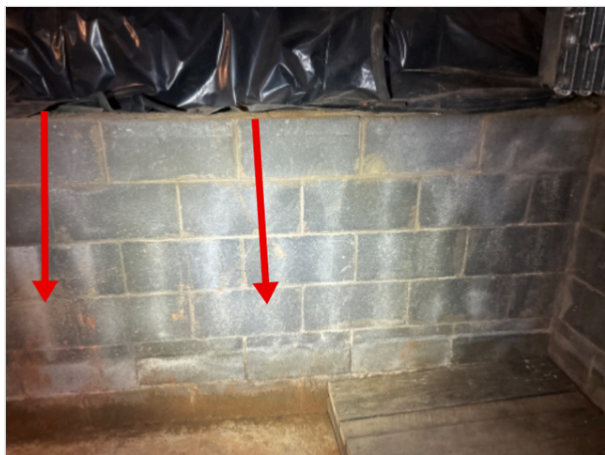
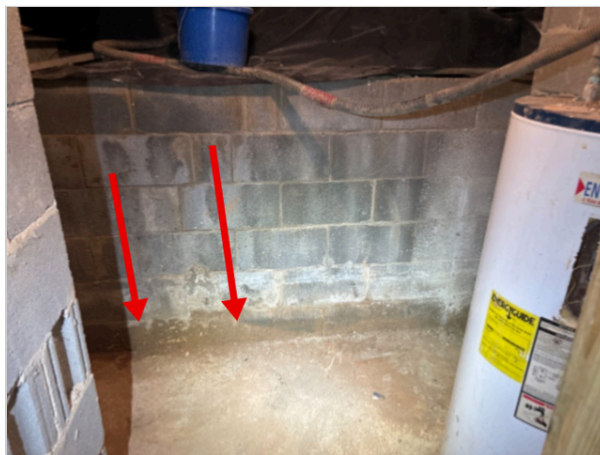
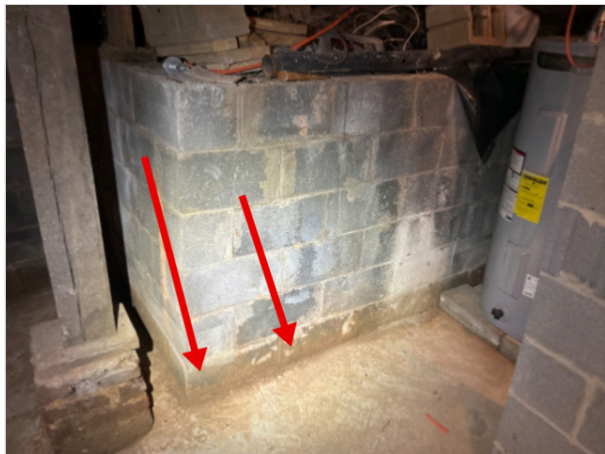
***Efflorescence/staining was observed on the foundation wall(s) at multiple areas of the cellar and crawlspace. This is a water penetration/adverse moisture concern. Recommend repairs as necessary by a qualified contractor.***

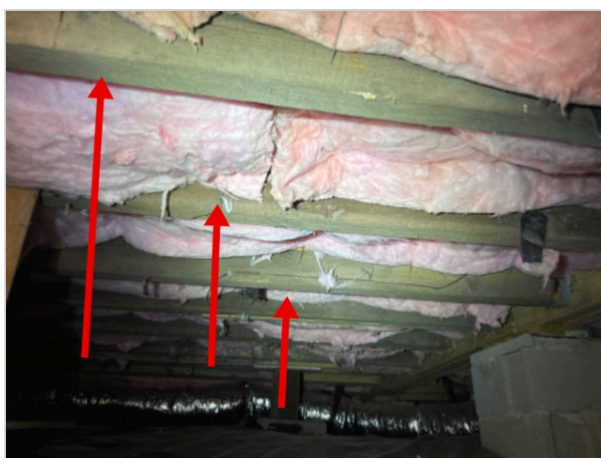
***Fungal like growth was observed at areas on the wood framing throughout the crawlspace. This is an adverse moisture/damage concern. Recommend review and repairs as directed by a qualified contractor.***

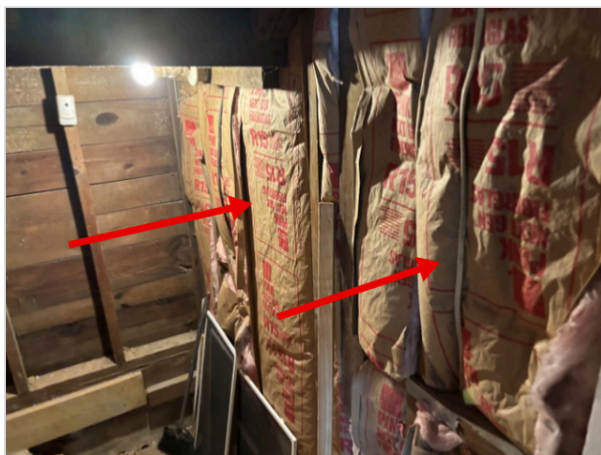
Stairs to cellar

***The insulation was installed in areas of the crawlspace with the paper backing exposed. This is an installation/function concern as the paper backing is typically installed towards the conditioned side of the house. Recommend repairs by qualified contractor.***

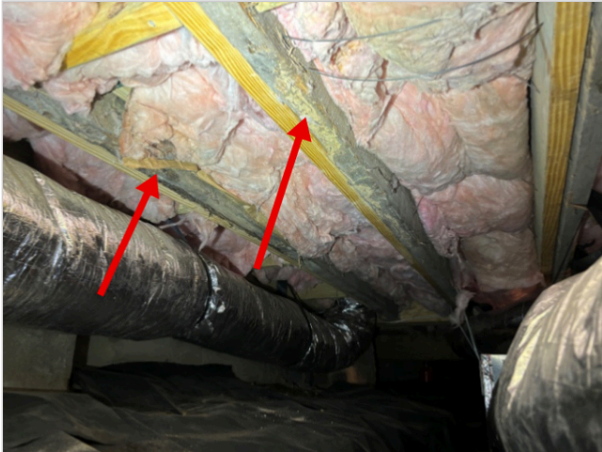
Front

***Possible wood destroying insect evidence observed at but not limited to Cellar crawlspace. This is a possible pest/damage concern. Recommend evaluation by qualified contractor and/or pest technician.***

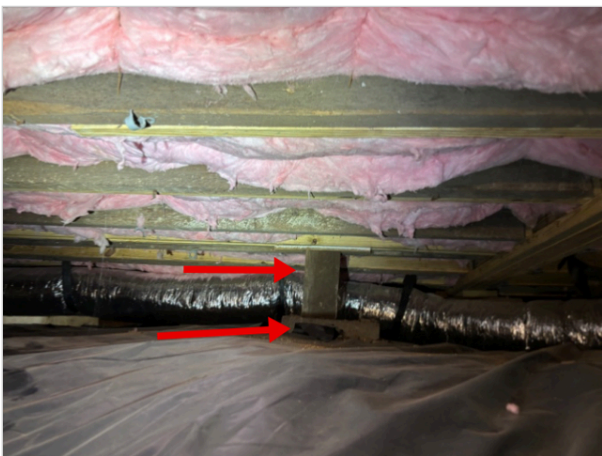
Middle

***Columns/piers, that did not appear to be original to the structure, were installed in the crawlspace that were temporary piers. This is a support/installation/movement concern. Recommend review and repairs by qualified contractor.***
