Re: *3006 N. Patterson Ave, Winston Salem, NC limited structural inspection*

The purpose of this report is to describe the conditions observed during the limited structural inspection at 3006 N. Patterson Ave, Winston Salem, NC for Rudy's Contracting Services LLC.

The purpose of the repair inspection was to observe the completed structural repairs. This firm completed a structural design to repair damaged structural components. In addition, the contractor removed (2) 1<sup>st</sup> floor walls for which this firm has designed headers. The scope of this inspection is limited to inspecting the completed repairs and determining if repairs were properly completed as designed.

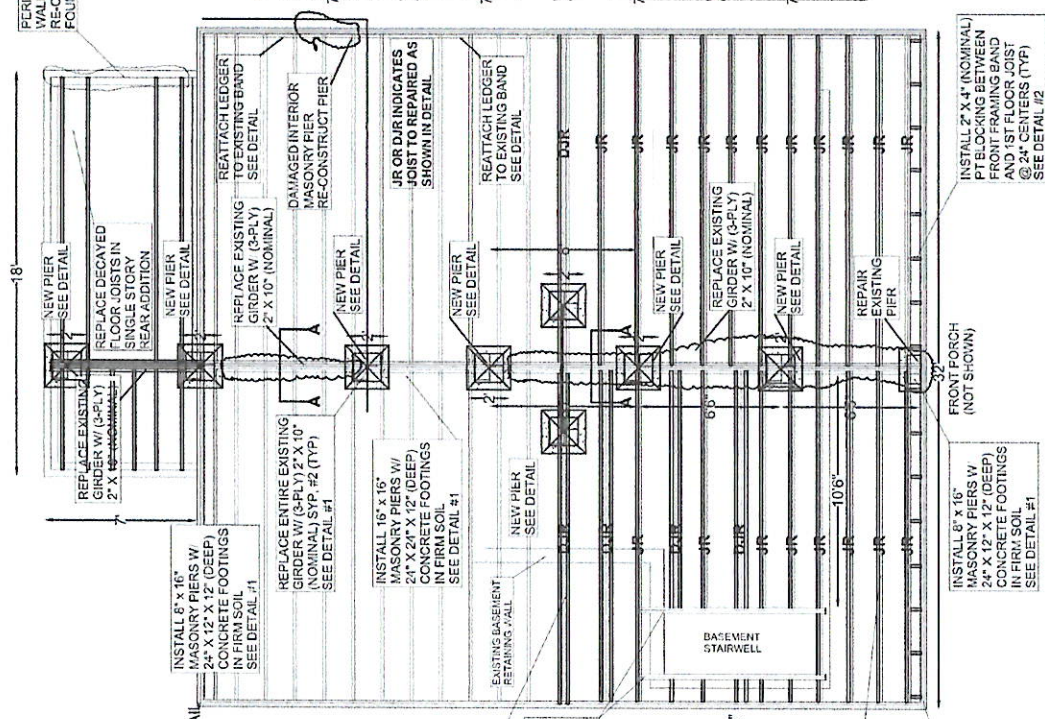
(PLAN VIEW) 1ST FLOOR FRAMING REPAIR DESIGN <sup>2/1</sup>

**THIS PLAN IS TO REPAIR THE TERMITE DAMAGED FLOOR FRAMING. THE FLOOR FRAMING PRIMARILY GIRDERS ARE SIGNIFICANTLY DECAYED BEYOND REPAIR. MANY OF THE GIRDERS MUST BE REPLACED**

ALL ENGAGED GIRDERS ARE DECAYED  
GIRDERS MUST BE REPLACED  
THE EXISTING GIRDERS SHOULD  
BE REMOVED AND REPLACED  
BY REMOVING THE 1ST FLOOR  
SUBFLOOR  
A NEW GIRDERS SHOULD BE  
INSTALLED ACCORDING TO THE  
DETAILS IN THIS DRAWING.  
NEW PIERS SHOULD BE INSTALLED  
ACCORDING TO THE  
DETAILS IN THIS DRAWING.

OBSERVED MANY DAMAGED FLOOR JOISTS. THE DAMAGED FLOOR JOISTS ARE PRIMARILY LOCATED IN THE FRONT AND RIGHT SIDE. THE DAMAGED JOISTS SHOULD BE REPAIRED ACCORDING TO THE FLOOR JOIST REPAIR DATA.

**(DOUBLE JOIST REPAIR) JR**  
REPAIR DAMAGED DOUBLE JOIST  
BY INSTALLING A 2" x 8" (NOMINAL)  
SYP. #2 ON EACH SIDE OF THE  
EXISTING DOUBLE JOIST  
FASTENING SHOWN IN DETAIL #3

INSTALL (3-PLY) 2" x 8"  
(NOMINAL) HEADER TO  
SUPPORT ENDS OF JOISTS  
EXISTING STAIRCASE MAY  
REQUIRE ENLARGEMENT

**(JOIST REPAIR) JR**  
BY INSTALLING 2" X 8" (NOMINAL)  
SYP. #2 ALONGSIDE DAMAGED  
FLOOR JOISTS FOR FULL LENGTH  
(CENTER GIRDER TO FOUNDATION)  
FASTEN NEW JOIST TO EXISTING JOIST  
W/ (2-ROWS) 1/4" X 3 1/2" STRUCTURAL  
FASTENERS; (2-ROWS) @ 12" CENTERS

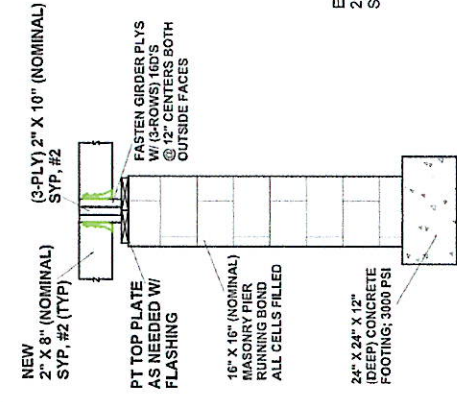
(DETAIL #1) GIRDER REPLACEMENT AND PIER DESIGN  
SECTION A-A

New masonry piers and footings were constructed below the new center girder at several locations.

INSTALL 8" x 16"  
MASONRY PIERS W/  
24" X 12" X 12" (DEEP)  
CONCRETE FOOTINGS  
IN FIRM SOIL  
SEE DETAIL #1

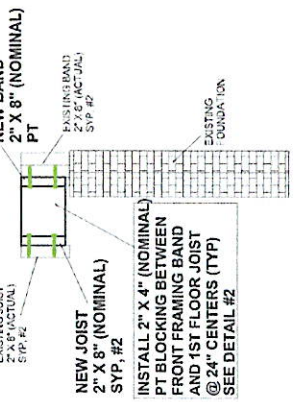
**(DETAIL #2) FRAMING BAND REPAIR**

The 1<sup>st</sup> floor band beam was decayed at the front foundation wall. The repair for the framing band is shown in the attached CAD drawings. Also, the right framing band ledger was not well attached.

INSTALL PT. 2" X 8" (NOMINAL)  
ALONGSIDE EXISTING DECAYED  
FRAMING BAND ABOVE FOUNDATION  
FASTEN NEW TO EXISTING BAND  
W (2-ROWS) 1/4" X 3 1/2" STRUCTURAL  
FASTENERS: (2-ROWS) @ 12" CENTERS

INSTALL 2" X 4" (NOMINAL)  
PT BLOCKING BETWEEN  
FRONT FRAMING BAND  
AND 1ST FLOOR JOIST  
@ 24" CENTERS (TYP)  
SEE DETAIL #12
