### HOME INSPECTION REPORT

File Number: **NC0416032**  
Address of Inspection: **4204 Sylvia Street**

**Alex Molina**  
**4204 Sylvia Street**  
**Winston Salem , NC 27104**

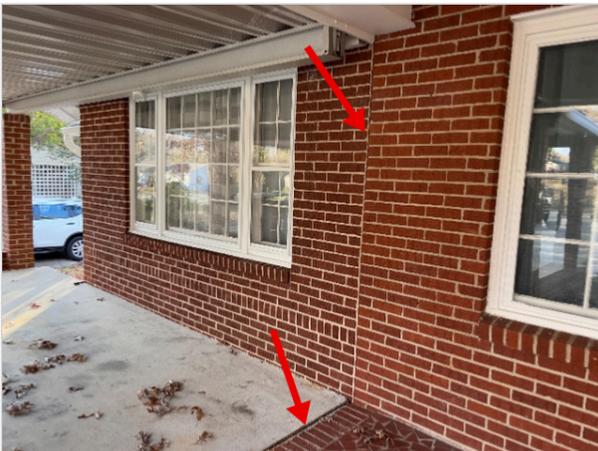
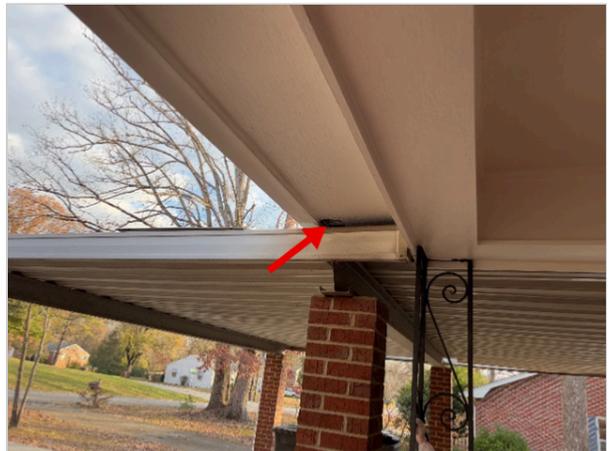
Front

***Damaged and unsealed areas observed at multiple areas of the siding/trim on the house. This is a water penetration/damage concern. Recommend repairs by a qualified contractor.***

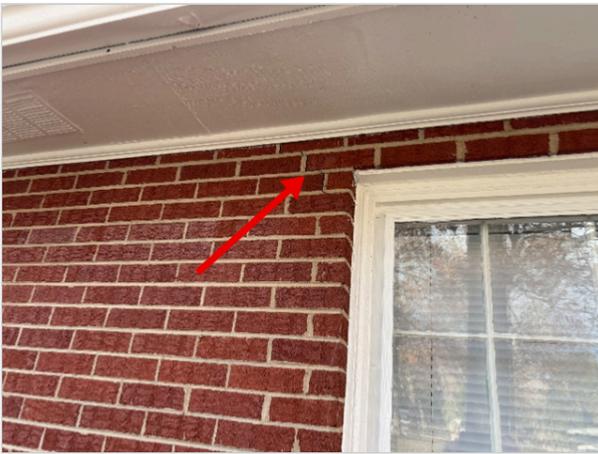
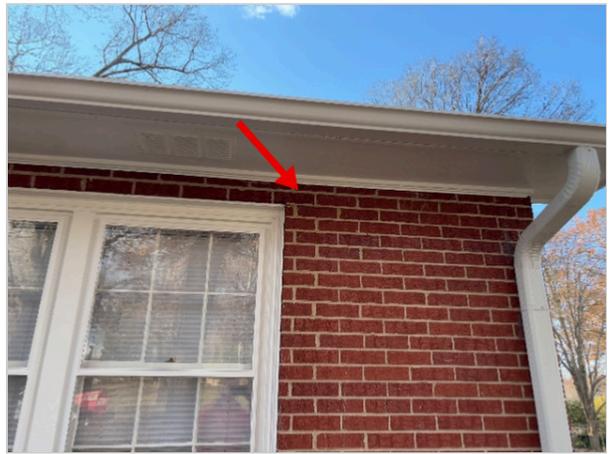
Front

**Wall cracking/open gaps observed at The front. This is a settlement/water penetration concern. Recommend repairs by a qualified contractor.**

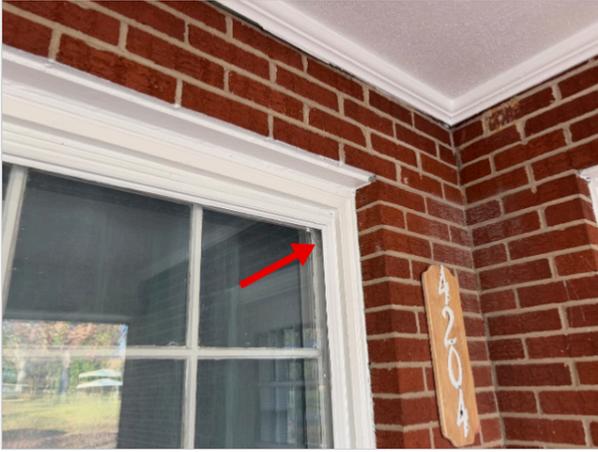
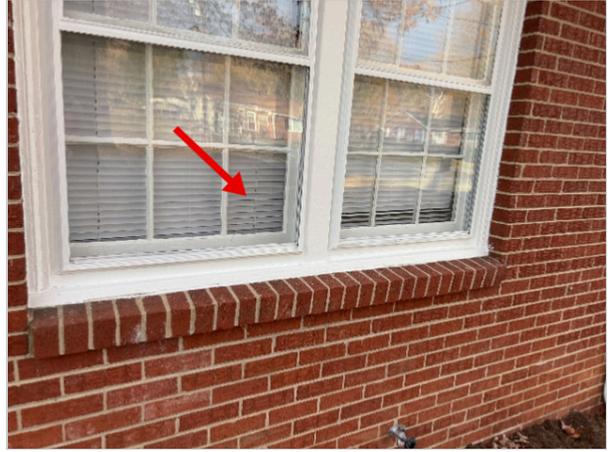
Front

**The window glazing was damaged/missing on areas of the windows around the exterior of the house. This is a function/damage concern. Recommend repairs as necessary by qualified person.**

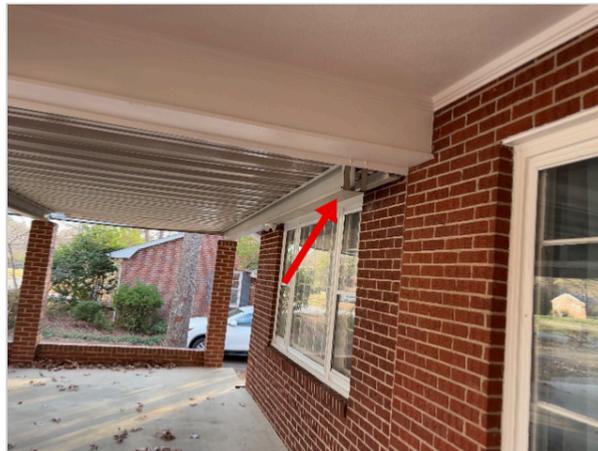
***The column(s) at the carport aren't properly bearing at the rear . This is a support/movement concern. Recommend repairs by a qualified contractor.***

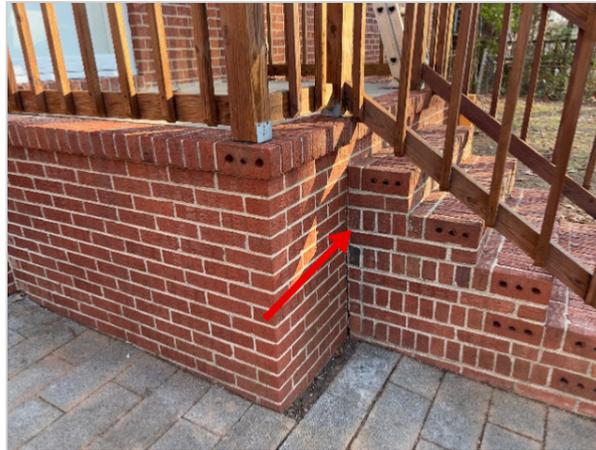
***Open mortar joints/cracking was observed at the rear porch. This is a water penetration/settlement concern.***

***Recommend repairs by a qualified person.***

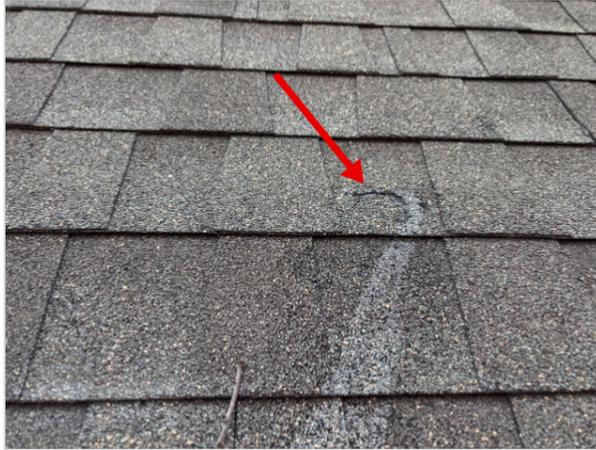
***Damaged shingles were observed at the front of the roof. This is a damage/water penetration concern. Recommend repairs by a qualified contractor.***

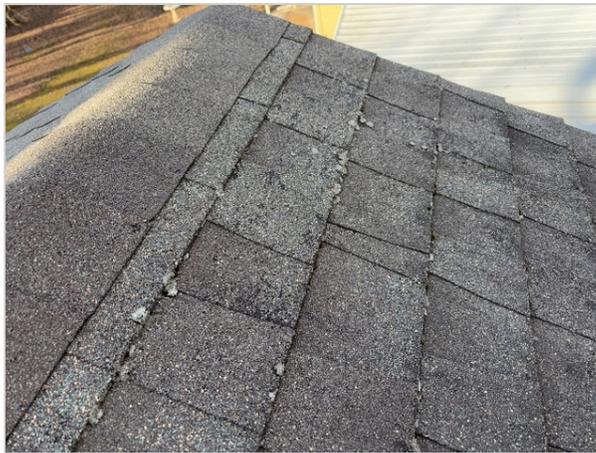
***Worn shingles with granular loss and fiberglass visible were observed on areas of the roof covering. This is a wear/damage concern. Recommend review and repairs as directed by a qualified contractor.***

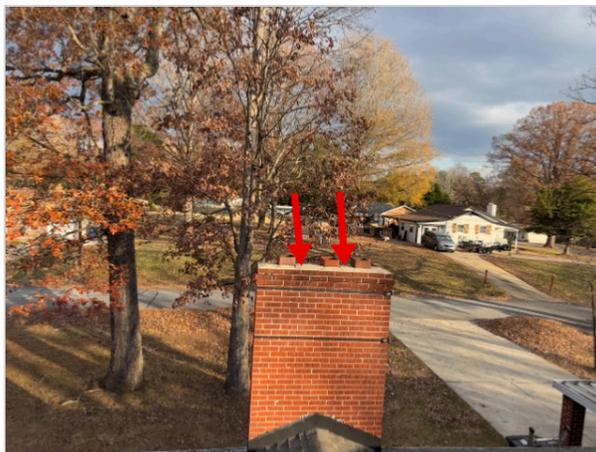
***Open cracking/joints were observed on the crown of the chimney at the exterior of the house. This is a water penetration/damage concern. Recommend repairs by a qualified contractor.***

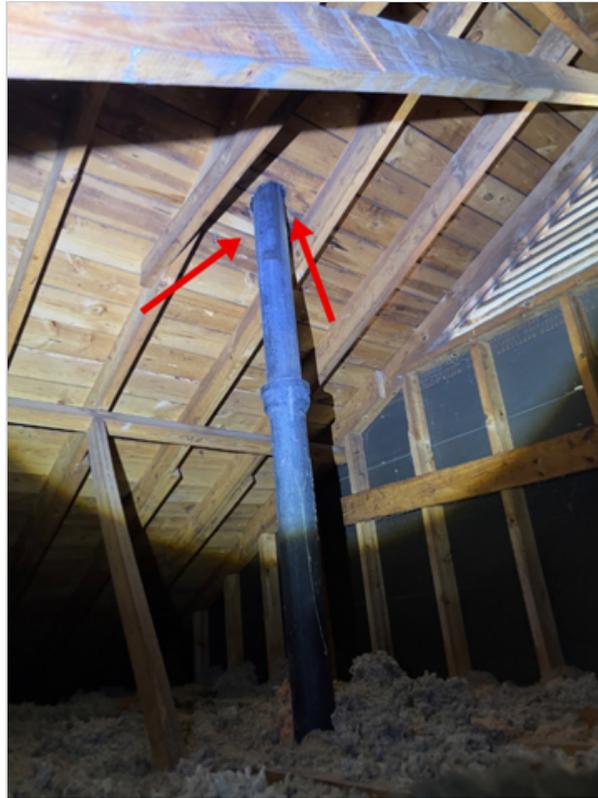
***Staining was observed on the framing at the rear of the attic. Moisture levels were not tested as area(s) was inaccessible. This is a leakage/damage concern. Recommend verifying conditions and/or having further review and repairs as necessary by a qualified contractor.***

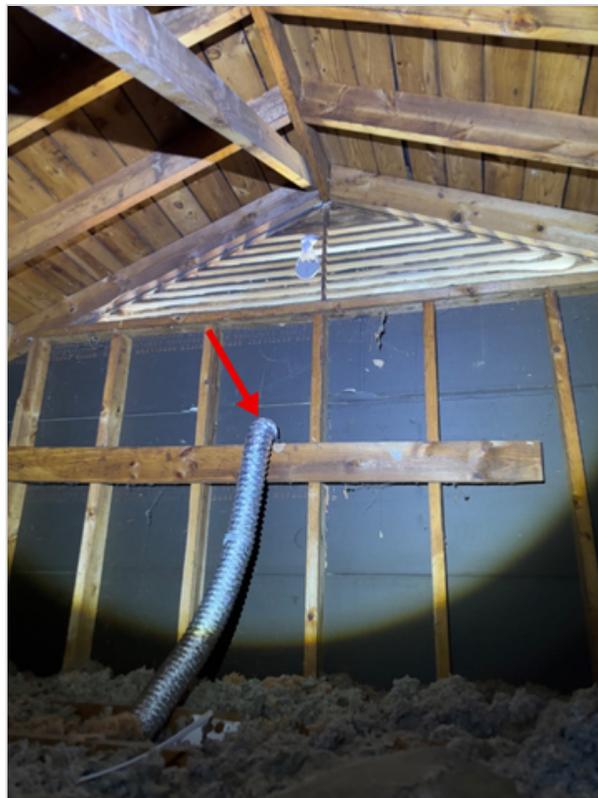
*The bathroom exhaust vent pipe(s) were discharging into attic and not to the exterior. This is a ventilation/ moisture build up concern. Recommend repairs by a qualified person.*

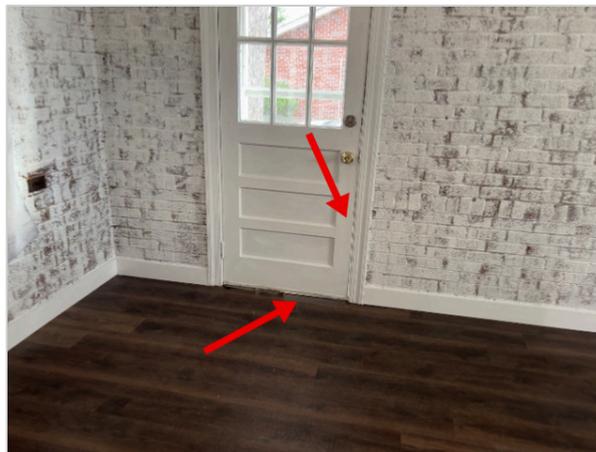
Left door

***Unsealed areas/open gaps were observed around the exterior door(s) at Multiple exterior doors. This is a conditioned air loss and water penetration concern. Recommend repairs by a qualified person.***

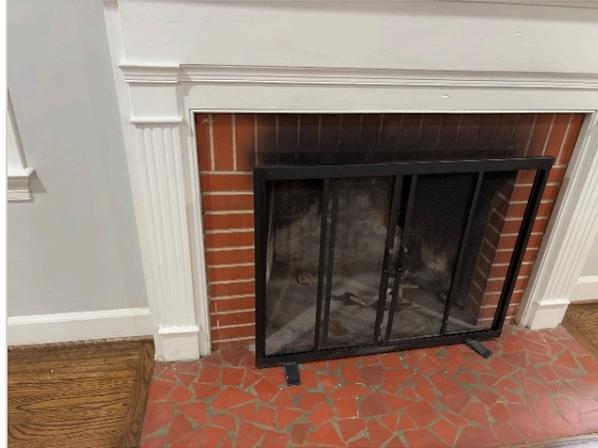
***No damper was installed at fireplace in the family room. This is a conditioned air loss/function concern. Recommend repairs by a qualified contractor.***

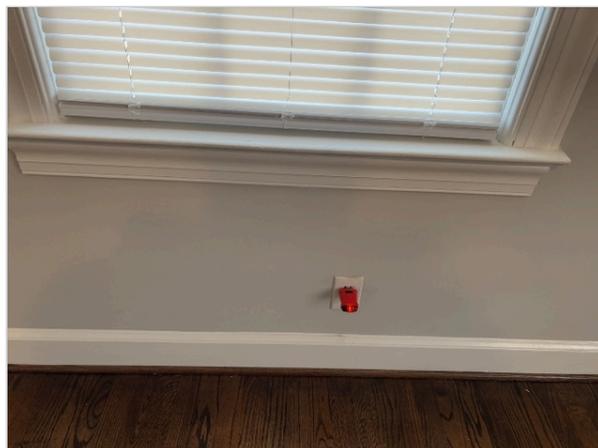
**3 prong electrical outlets tested with an open ground at Multiple areas. This is a safety/wiring concern. Recommend review and repairs as directed by a qualified contractor.**

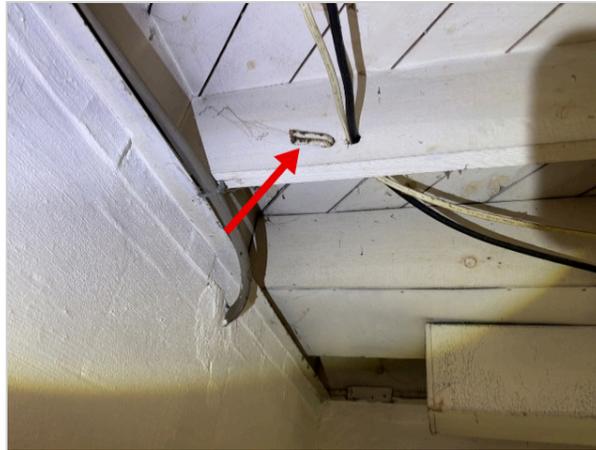
**Exposed wires observed at The basement without being sealed in a junction box. This is a damage/shock concern. Recommend repairs by a qualified contractor.**

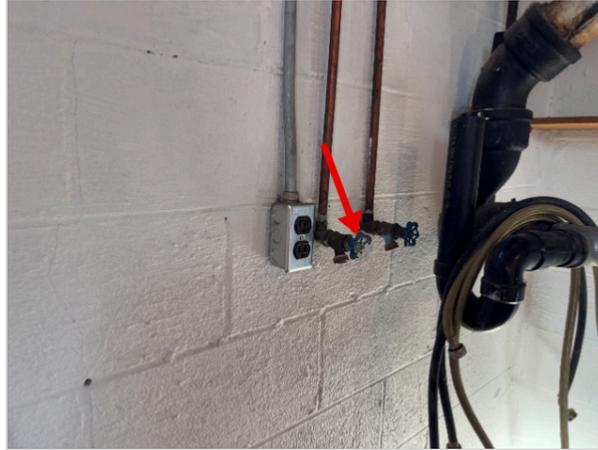
**The laundry water line handle was damaged. This is a function concern. Recommend repairs by a qualified person.**

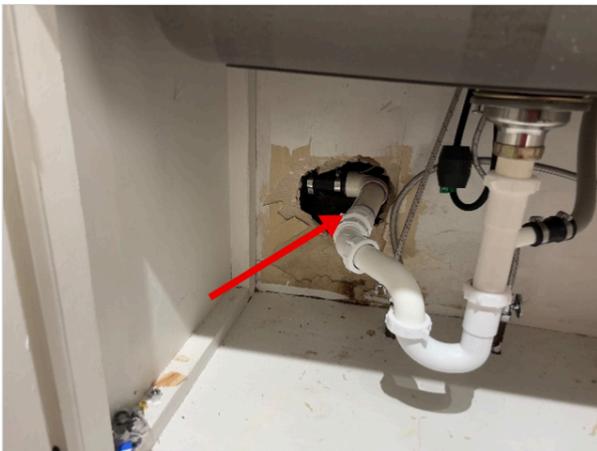
Kitchen sink

***Improper drain pipe sloping was observed at Multiple areas. This is an installation/drainage concern. Recommend repairs by a qualified contractor.***

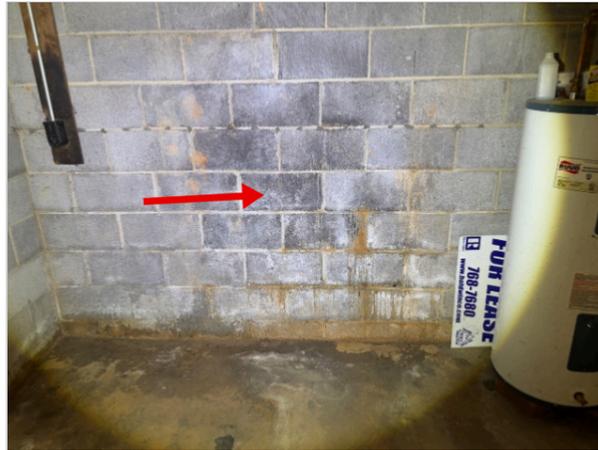
Rear

***Efflorescence/staining was observed on the foundation wall(s) at multiple areas of the basement. This is a water penetration/adverse moisture concern. Recommend repairs as necessary by a qualified contractor.***

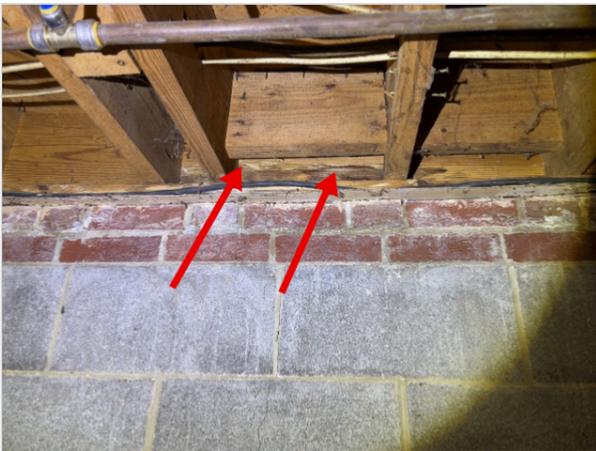
Rear

**Staining with damage was observed at Multiple areas. This is a leakage and damage concern. Recommend review and repairs as directed by a qualified contractor.**

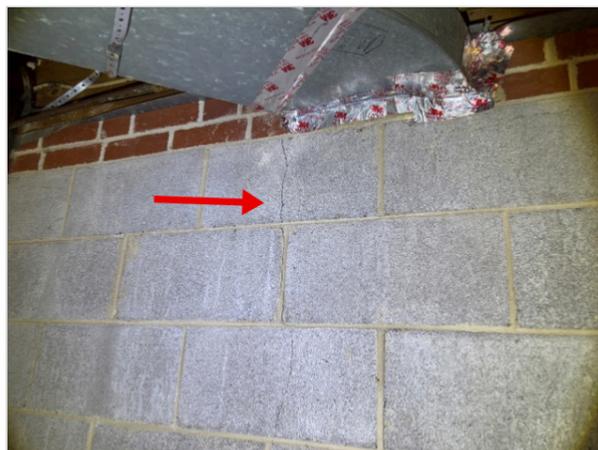
Left

**Cracking was on areas of the foundation wall(s) at multiple areas of the basement. This is a settlement/water penetration concern. Recommend repairs by qualified contractor.**
