### *HOME INSPECTION REPORT*

File Number: **NC0414961**

Address of Inspection: **3006 N Patterson Ave**

**Jose Melendez**  
**3006 N Patterson Ave**  
**Winston-Salem, NC 27105**

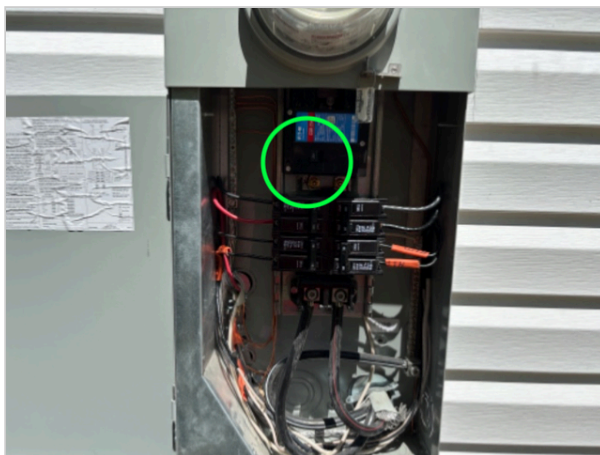
Main turn off

The main service panel is located on the exterior wall with an estimated 200 amp and 240 volt rated capacity. 120v branch circuits were copper. 240v branch circuits were aluminum and copper. The branch circuits were connected to breakers. There were no concerns observed within the main panel.

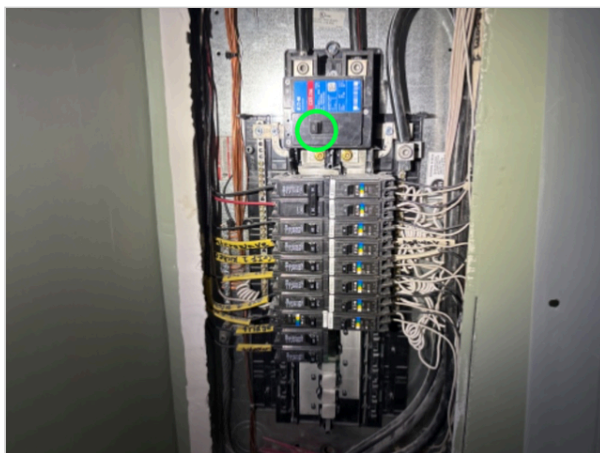
Shut off

A subpanel is located on the interior wall with an estimated 200 amp and 240 volt rated capacity. 120v branch circuits were copper. 240v branch circuits were aluminum and copper. These branch circuits were attached to breakers. There were no concerns observed within the sub panel.

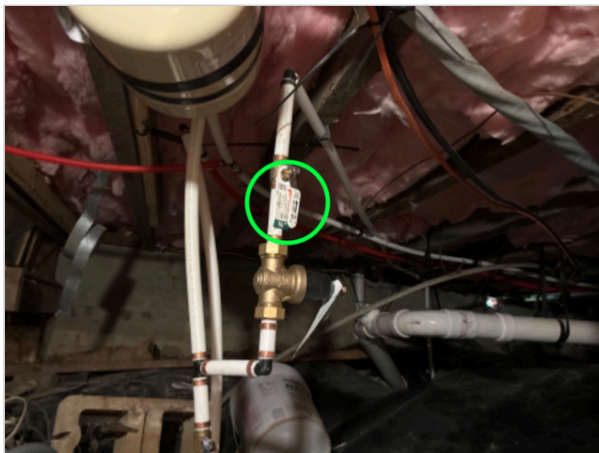
Main turn off

The main water shutoff valve for the home was next to the water heater. Water shutoff valves are visually inspected only. No attempt is made to operate the main or any other water supply shutoff valves during the inspection. These valves are infrequently used and could leak after being operated. This is for your information.
