Re: *3006 N. Patterson Ave, Winston Salem, NC limited structural inspection*

The purpose of this report is to describe the conditions observed during the limited structural inspection at 3006 N. Patterson Ave, Winston Salem, NC for Rudy's Contracting Services LLC.

The purpose of the repair inspection was to observe the completed structural repairs. This firm completed a structural design to repair damaged structural components. In addition, the contractor removed (2) 1<sup>st</sup> floor walls for which this firm has designed headers. The scope of this inspection is limited to inspecting the completed repairs and determining if repairs were properly completed as designed.

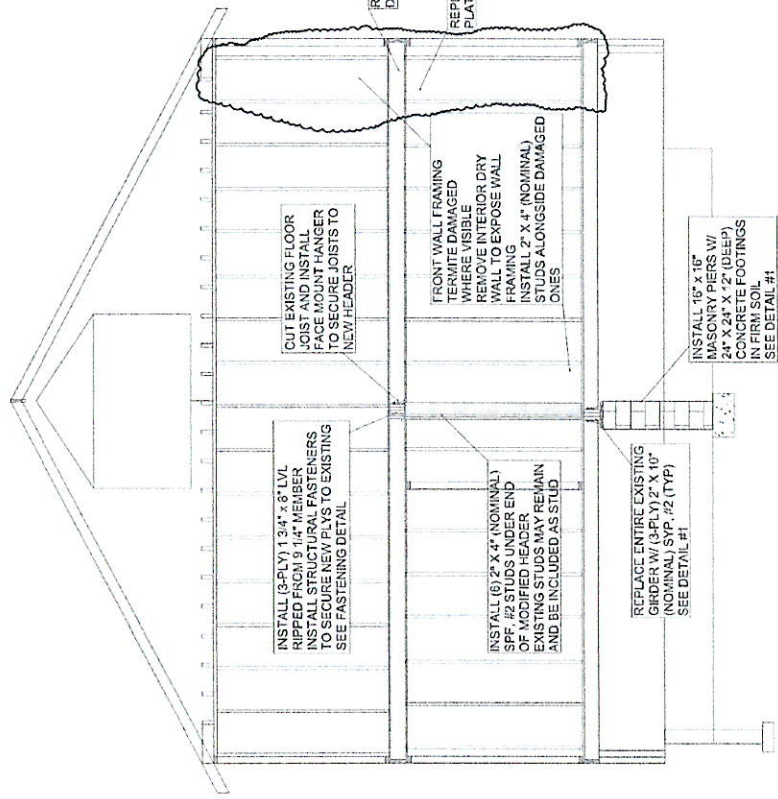
(ELEVATION) 1ST FLOOR FRAMING; FRONT VIEW  
2/1

The 1<sup>st</sup> floor band beam was decayed at the front foundation wall. The repair for the framing band is shown in the attached CAD drawings. Also, the right framing band ledger was not well attached.

I completed an inspection on November 3, 2023. The framing band areas were properly repaired as designed.

INSTALL PT. 2" X 8" (NOMINAL)  
ALONGSIDE EXISTING DECAYED  
FRAMING BAND ABOVE FOUNDATION  
FASTEN NEW TO EXISTING BAND  
W (2-ROWS) 1/4" X 3 1/2" STRUCTURAL  
FASTENERS: (2-ROWS) @ 12" CENTERS
