### HOME INSPECTION REPORT

File Number: **NC0416032**  
Address of Inspection: **4204 Sylvia Street**

**Alex Molina**  
**4204 Sylvia Street**  
**Winston Salem , NC 27104**

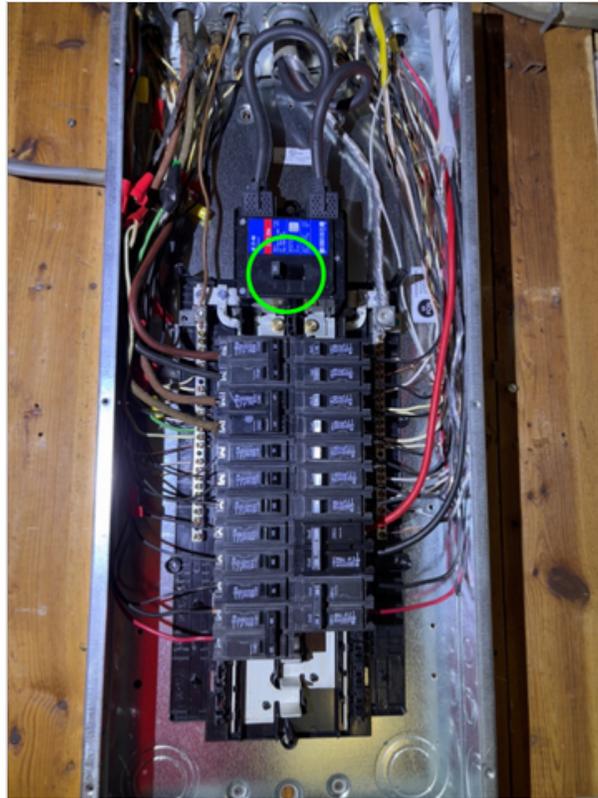
Main Turn off

The main service panel is located on the basement wall with an estimated 200 amp and 240 volt rated capacity. 120v branch circuits were copper. 240v branch circuits were aluminum and copper. The branch circuits were connected to breakers. There were no concerns observed within the main panel.

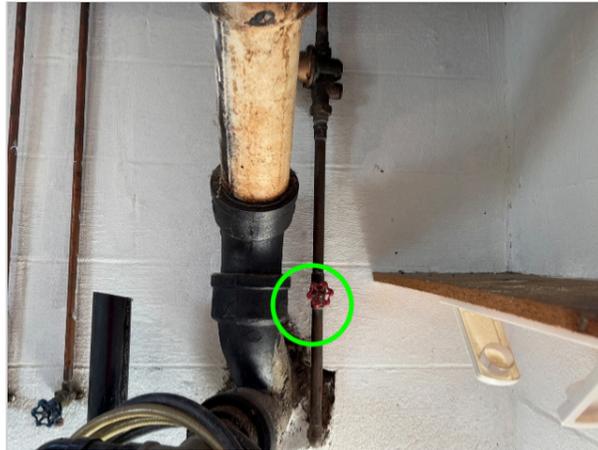
Main Turn off

The main water shutoff valve for the home was in the laundry room. Water shutoff valves are visually inspected only. No attempt is made to operate the main or any other water supply shutoff valves during the inspection. These valves are infrequently used and could leak after being operated. This is for your information.
